US EPA-APPROVED
TOTAL MAXIMUM DAILY LOAD (TMDL)
FOR
UPPER RIO GRANDE WATERSHED

SEPTEMBER 13, 2012

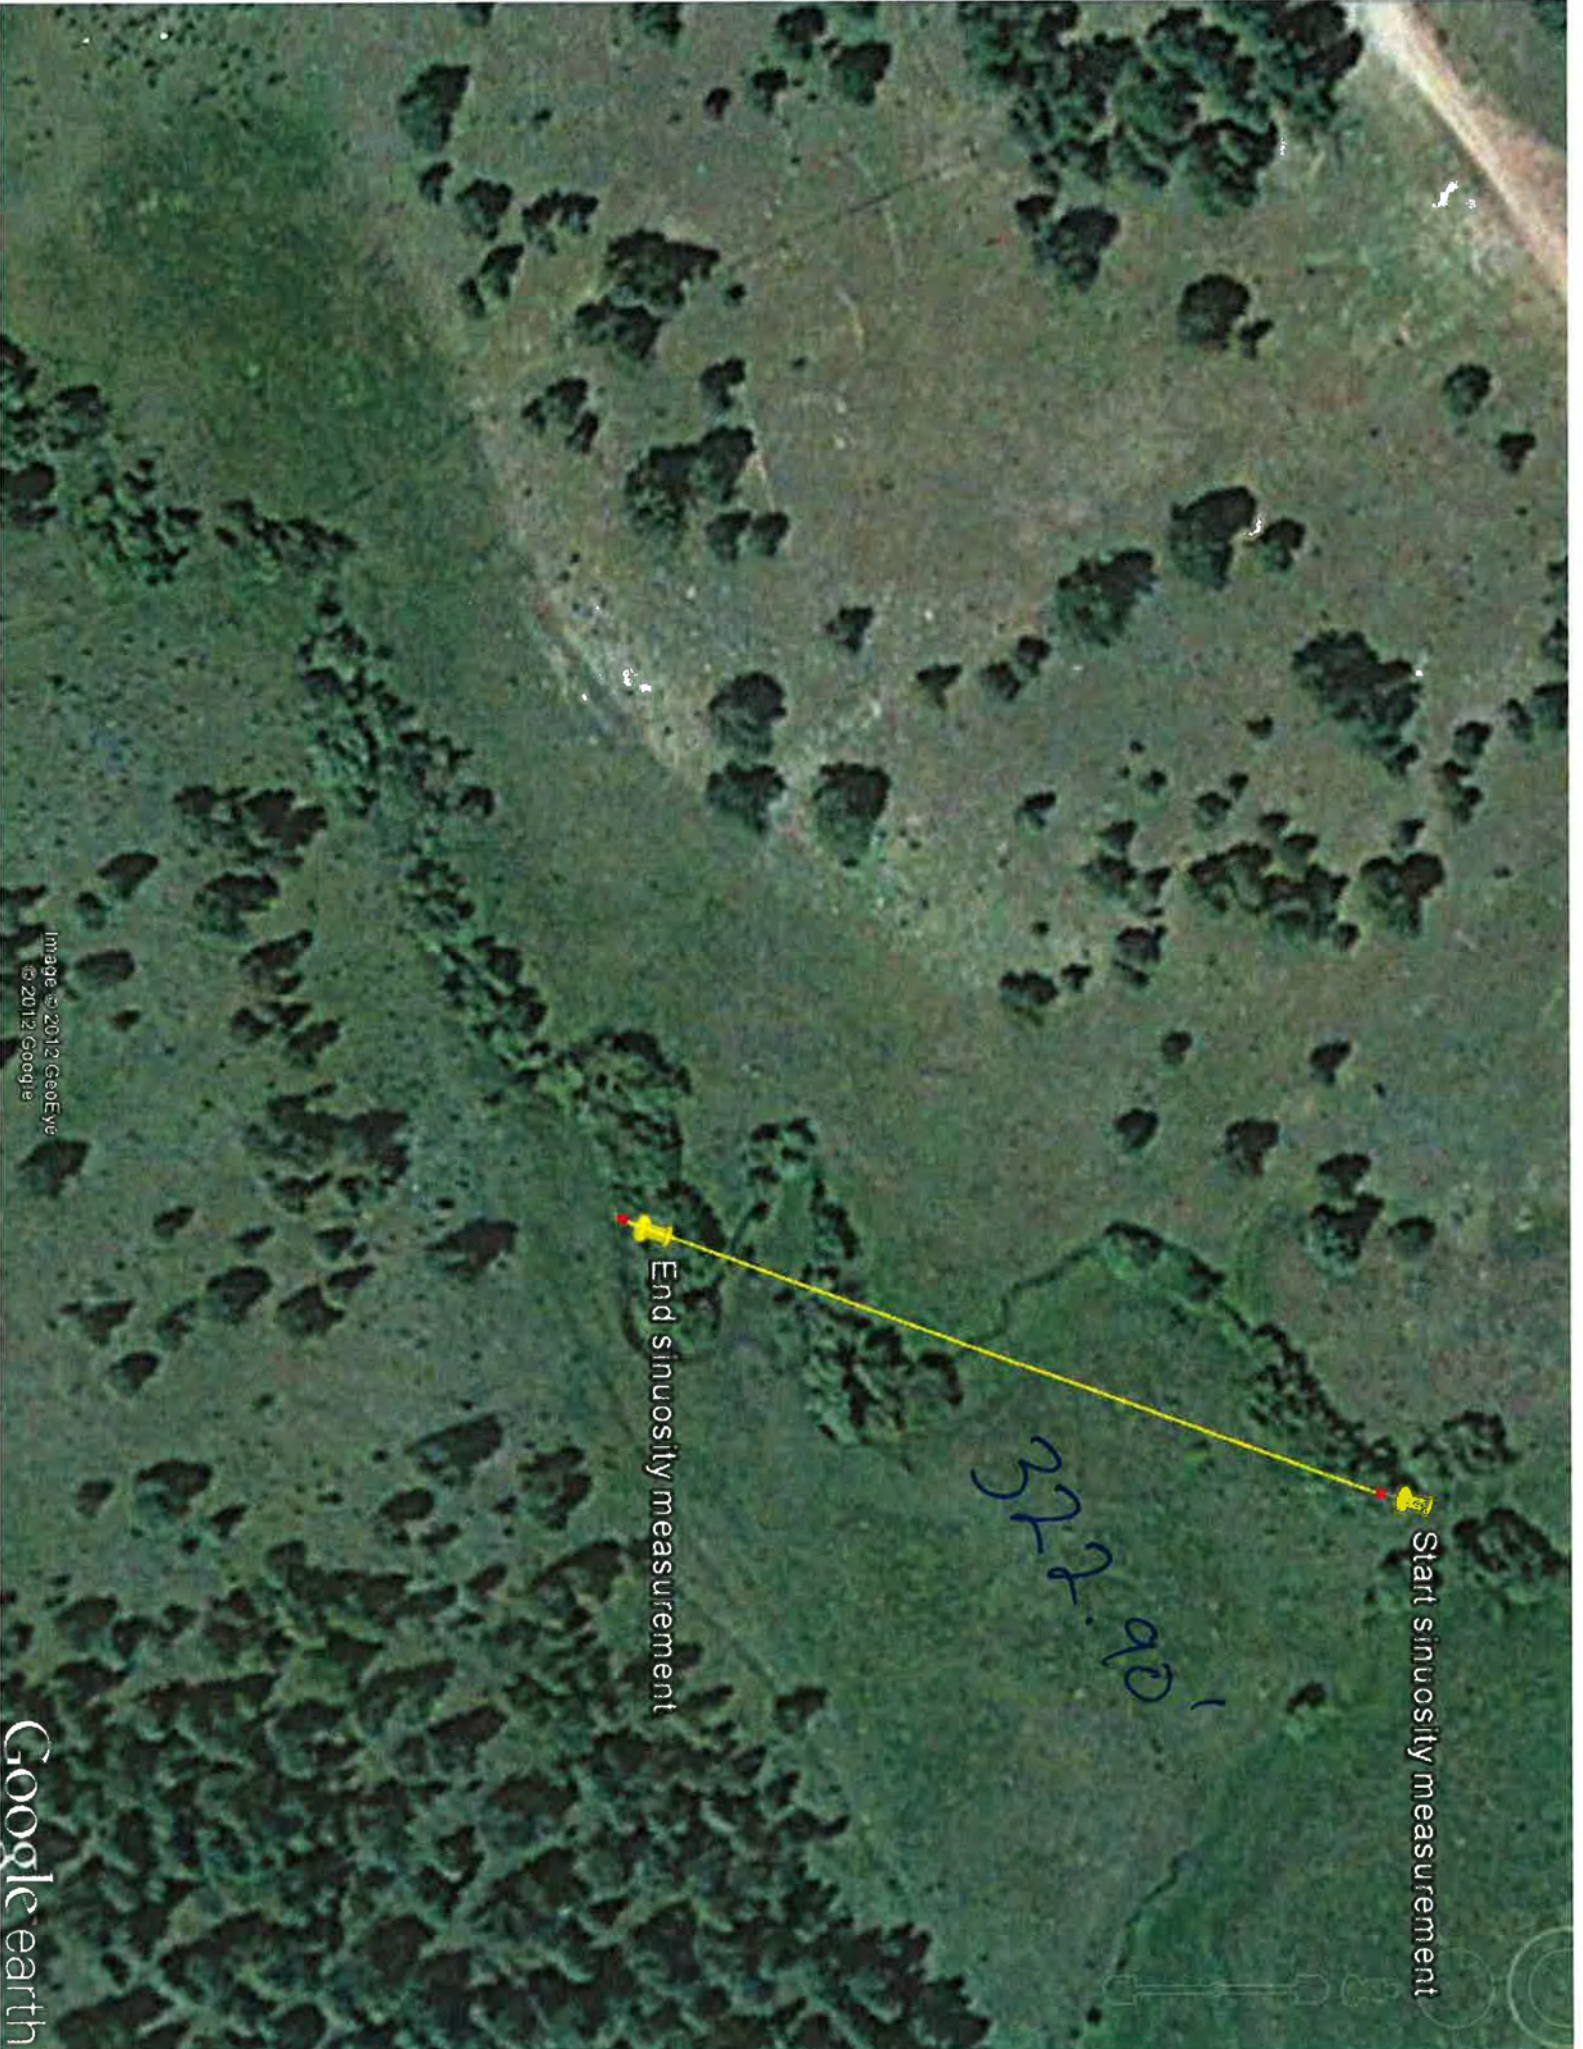
Start sinuosity measurement

End sinuosity measurement

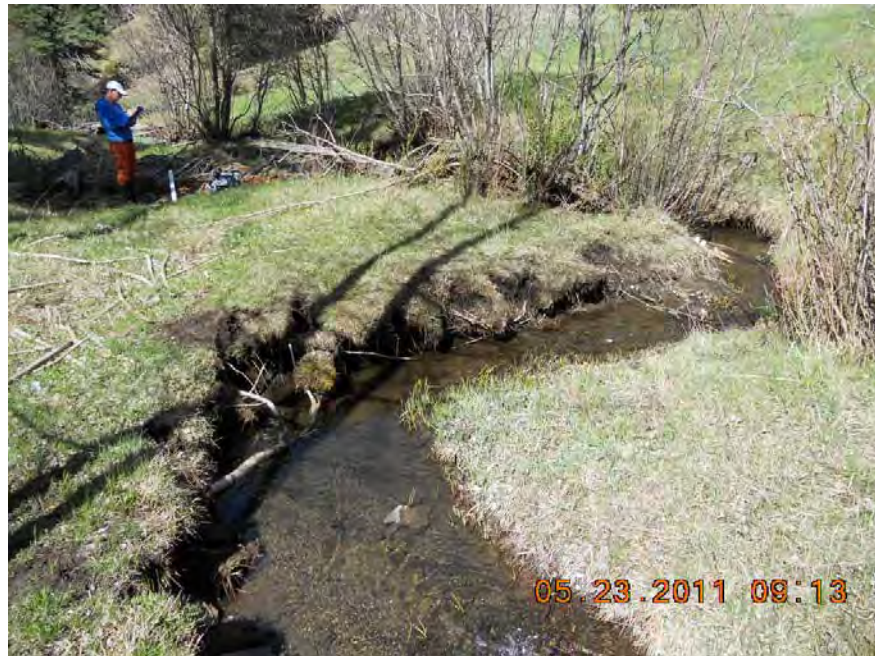
Photo 2. Rio Fernando de Taos (looking downstream of Highway 64)

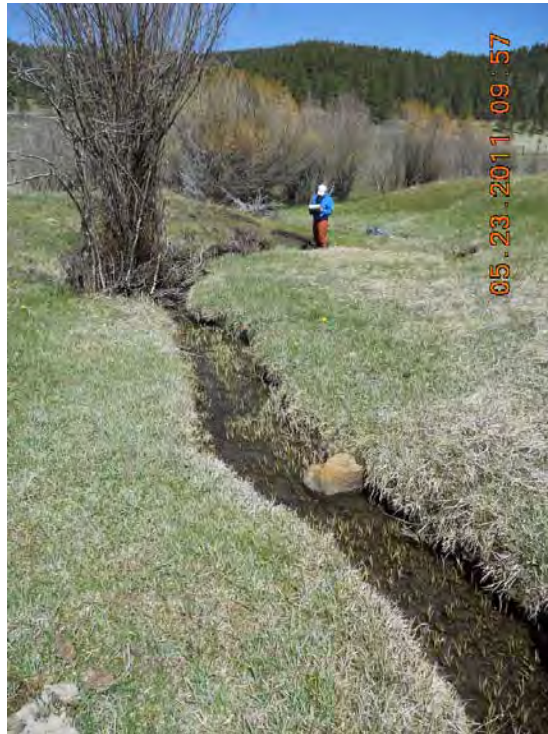
Photo 2. Apache Canyon (riparian vegetation on Rio Fernando de Taos below the elk exclosure in background)
